# Stinger Information Bulletin

## Stinger Informational Bulletin 2025-2

### Gateway Gen 2 Traction Cable Improvement

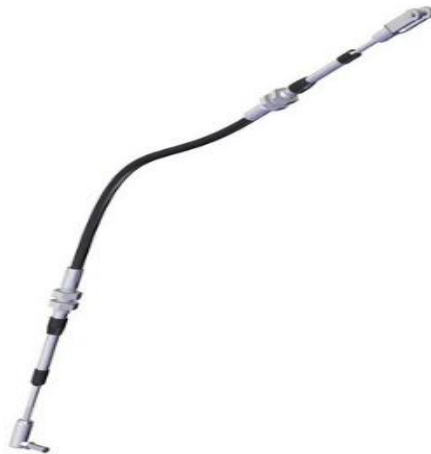
Improved traction cable was designed to replace the initial traction cable on Gen 2 Gateways with Honda engines

To reduce the possibility of a traction cable failure, the cable design has been improved and a new replacement spring for the hydraulic pump linkage will supersede the original.

When a failure is encountered, it is recommended to replace the existing traction cable and the black spring located on the hydraulic pump control linkage. Replace them with the improved cable and silver spring – detailed installation instructions will be included with the kit.
