Stinger Bulletin 2023-1

Pump Seal – Hydro Cooler QA-3000

Low Pressure Return Hose Instructions

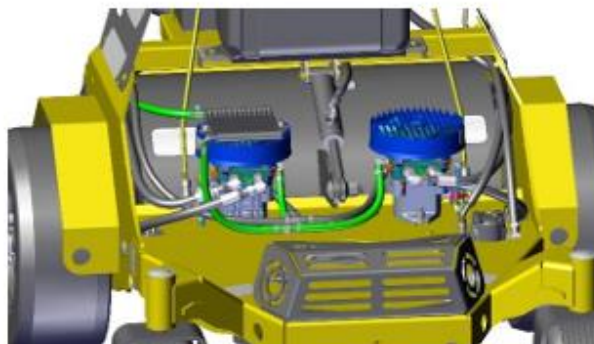
Previous Return Low-Pressure Hose Components (Green Hoses)

Part Number	Description	Qty
40-2380-1	3/8" Hose 5.25"	1
40-2380-2	3/8" Hose 11.50"	2
40-2380-9	3/8" Hose 35"	1
40-2274	5/8" Hose Clamp	7
40-1862	4504-6-6-6 T Fitting	1
2-1004	Zip Tie - 6"	2

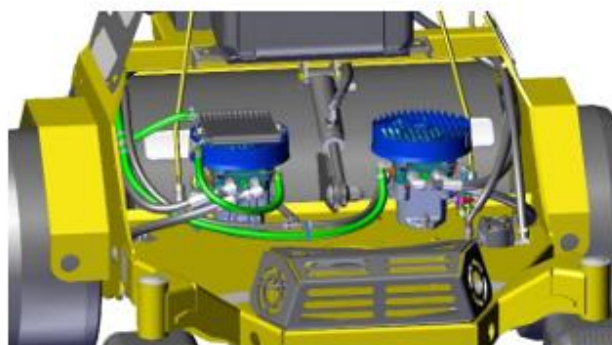
Revised Return Low-Pressure Hose Kit Components (Green Hoses)

Part Number	Description	Qty
40-4012	3/8" Hose 15.5"	1
40-4014	3/8" Hose 29.1"	1
40-4610	3/8" Hose 6.25"	0
40-2274	5/8" Hose Clamp	6
40-1862	4504-6-6-6 T Fitting	1
2-1004	Zip Tie - 6"	2
	Kit Plug	3

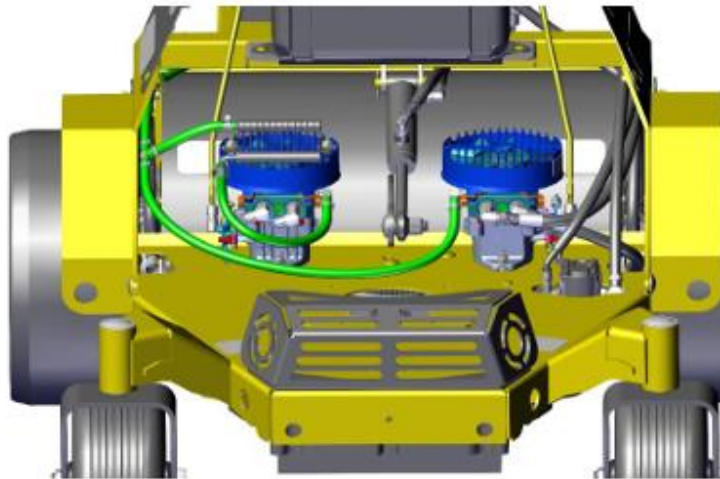
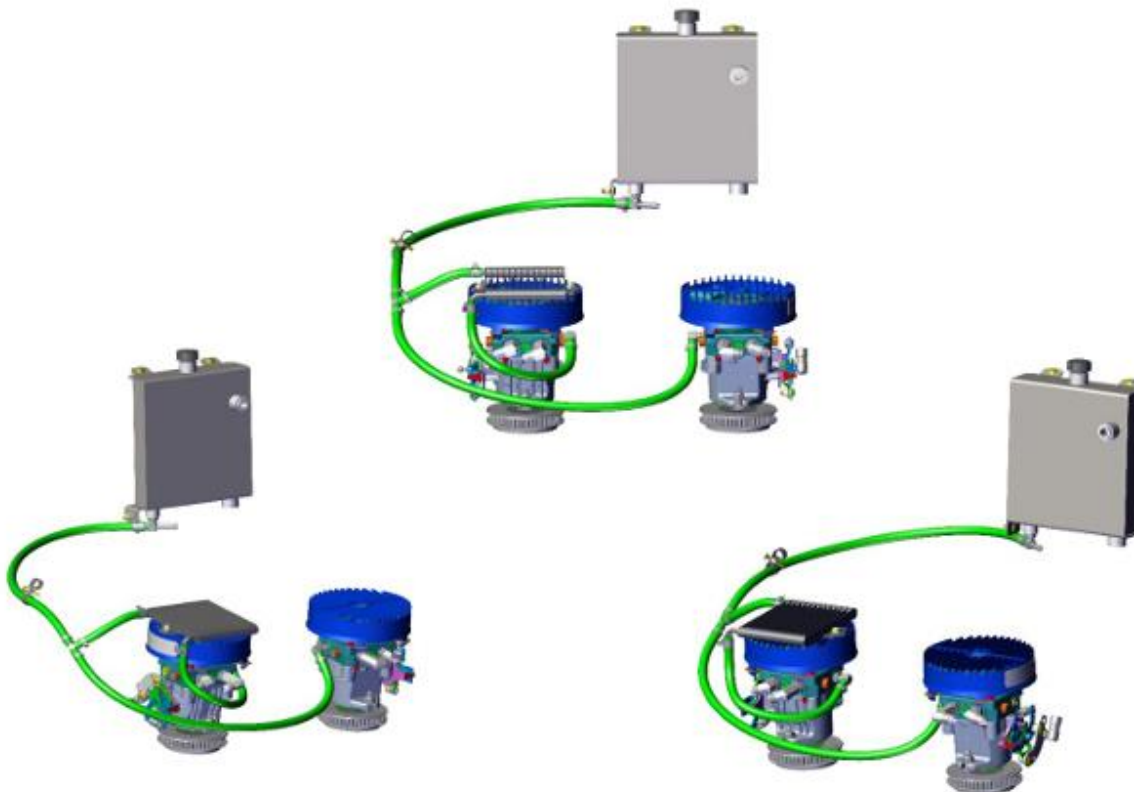
- Step 10 Route 40-4014 hose to right side going under wiring harness and up towards return.
- Step 11 Measure 6 - 6.5" from oil cooler return and cut line (plug if preferred)
- Step 12 Install clamp on both ends of the cut hose.
- Step 13 Connect the ~6" hose to the T fitting.
- Step 14 Connect the other cut return to the T fitting.
- Step 15 Ensure all 6 clamps are tight.
- Step 16 Clean any residual oil from the unit.
- Step 17 Place a zip tie around two low pressure hoses at the T-fitting near the engine.
